OHRD METALLURGICAL INVESTIGATION OF PRESSURE TUBES REMOVED FROM PICKERING 'B' UNIT 8

Report No 85-293-K

job	file	date	report no.
740684-129-451	823.21	October 8, 1985	85-293-K

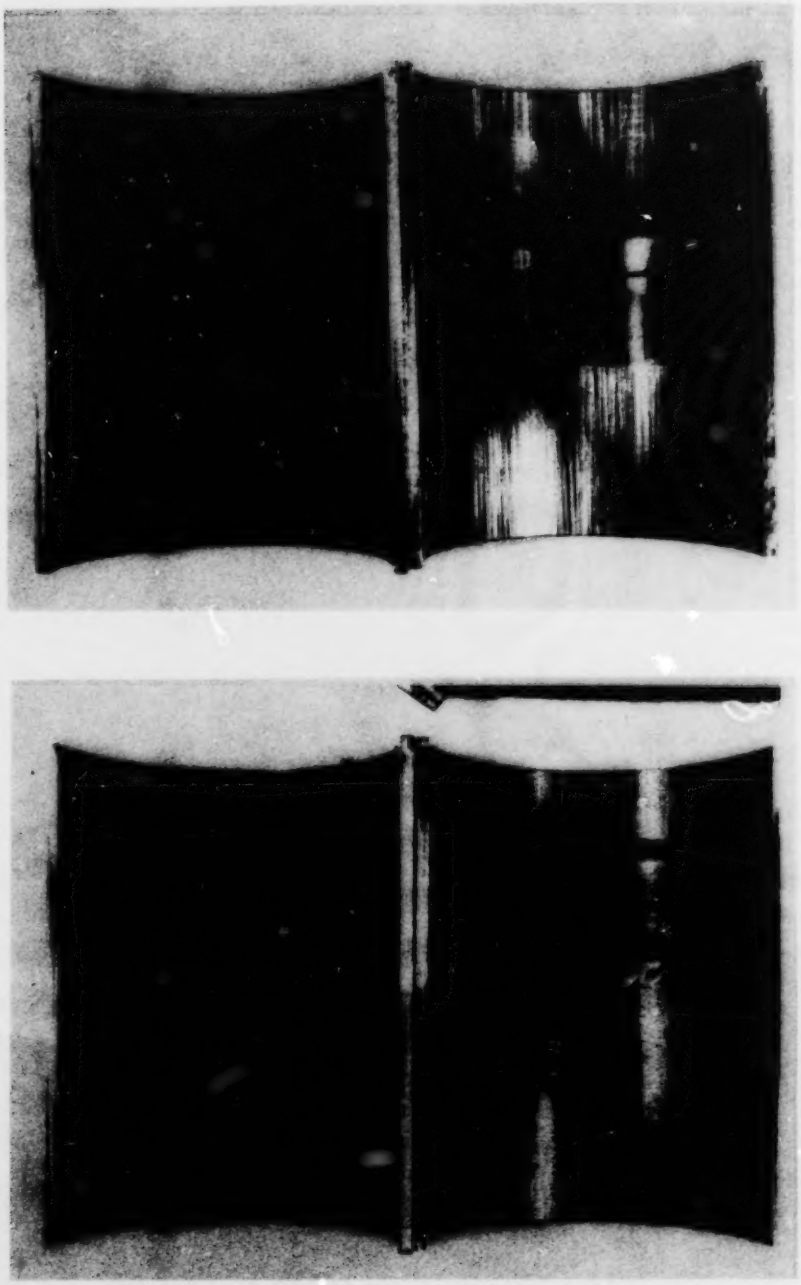
Features (i), (ii) and (iv) are visible on low magnification photographs taken for the record. Two examples of these are shown in Figure 1(a) and (b). Others are filed at OHRD.

FIGURE 1(a) - Macrophotograph of inside surface of channel F15 at the first fret mark. Note fretting due to contact of the cast iron with the pressure tube (0.4 X approx).

(b) - Macrophotograph of channel J12 at the second and third fret marks (0.4 X approx).

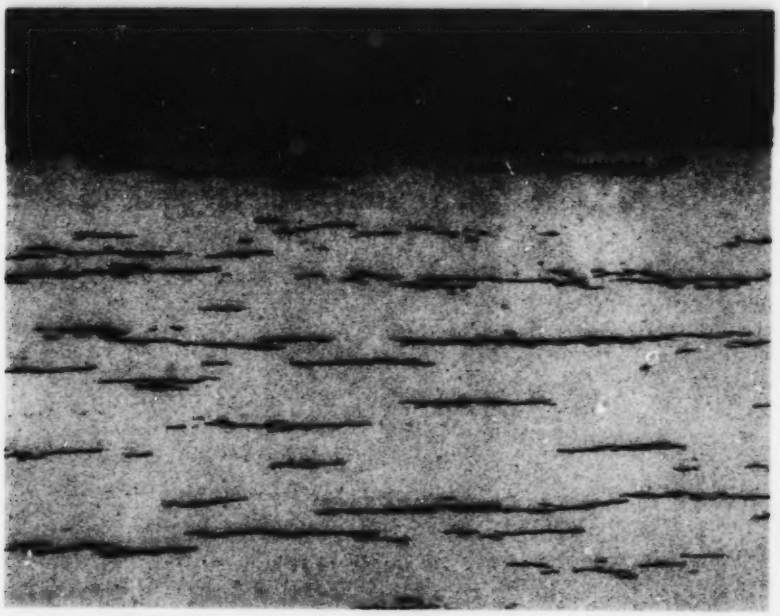
The microscopic examination of the cross sections through the broad, usually smooth areas produced by the bearing pad contacts on the pressure tube revealed a surface that was rougher than in the normal pressure tube. Features typical of those seen in many cross sections are shown in Figure 3(a-e). The apparent peak-to-peak surface roughness observed in the cross section shown in Figure 3(c) is in the range of 20-30 μm. A new pressure tube has a surface roughness more than an order of magnitude smaller. The axial-normal cross section shown in Figure 3(b) shows a fine crack parallel to the surface intersecting the surface at each end. In circumferential-normal section particles composed of alternate layers of metal and oxide, appear semicircular (Figure 3(c)). In other areas the particles are absent but the very small pit remains (Figure 3(a)). In many areas, especially in the more heavily hydrided areas, there were areas of the surface which were apparently solid hydride (Figure 3(e)) in a very thin layer (~5 μm).

FIGURE 3(a) - Surface roughness and hydride distribution in E8-1-4; transverse normal section (100 X).

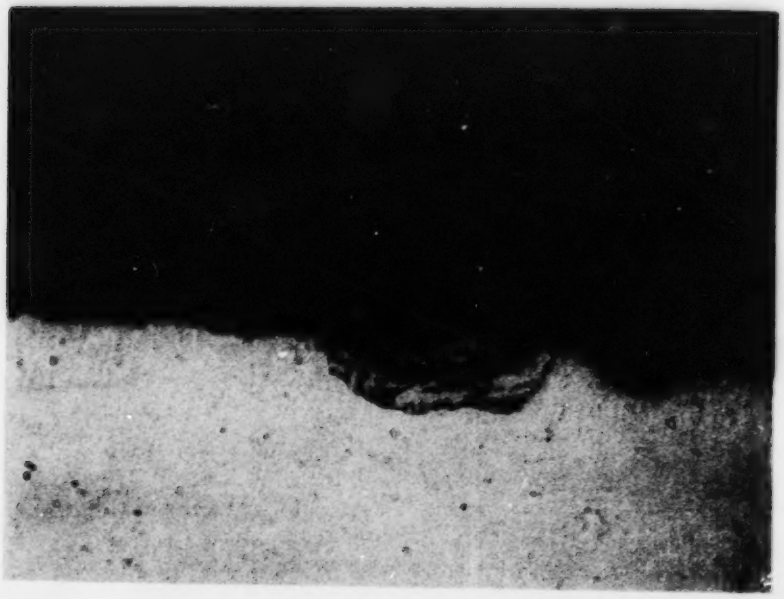
The metallographic evidence appears to indicate that material removal occurred by a mechanism involving formation of small cracks parallel to the surface (Figure 3(b)) followed by rolling up of the platelet formed by the cracking. These rolled up platelets (Figure 3(c)) were then carried away by the water. This mechanism is described in the literature as delamination wear/3,4,5/. In this case since the hydride forms platelets more or less parallel to the surface, the presence of such platelets close to the surface could accelerate the formation of the crack which produces the wear particles. Thus the wear rate and hydrogen pickup rate may be coupled in a complex way.

FIGURE 3(c) - Particle made up of rolled-up oxidized platelets in transverse normal section of sample E8-1-4B (1000 X).

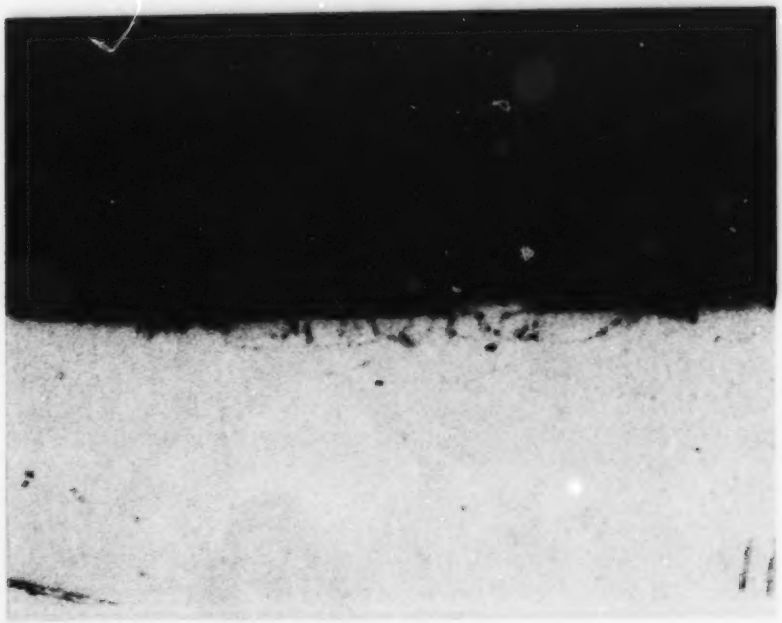
3. There are some areas of the pressure tube surface in the heavily fretted regions which are really thin layers of solid hydride.

FIGURE 3(e) - Area of solid surface hydride in E8-1-4 (1000 X)

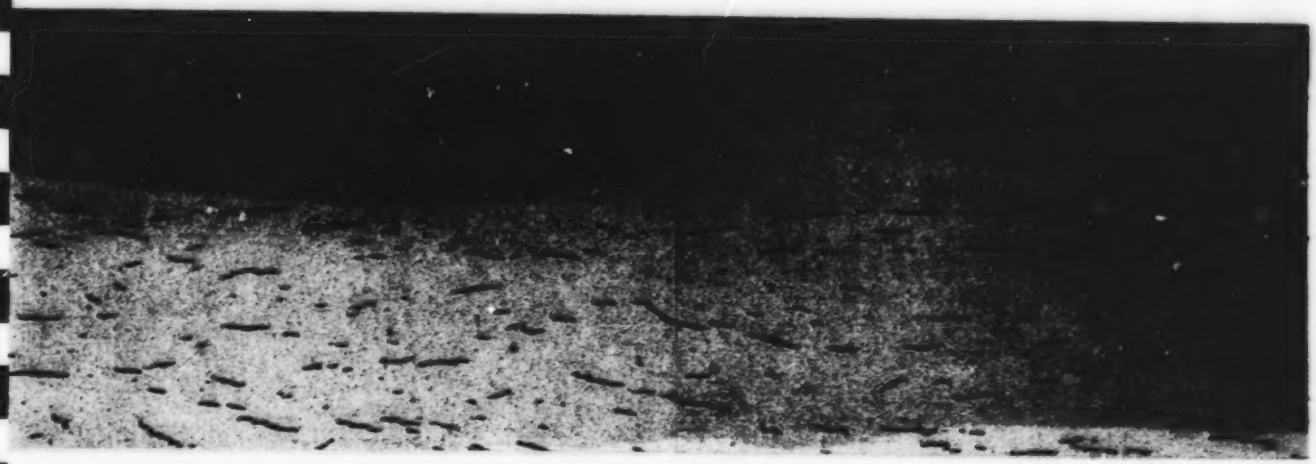
The tube surface geometries associated both with the axial ridges within the broad fret marks and with the circumferential ridges associated with the ends of the fretted zones were also examined. Of all the cross sections examined, those shown in Figure 4 are the most severe in terms of the abruptness of the change in section.

FIGURE 4(a) - Ridge geometry in axial-normal cross-section in G-10 at the first fret mark (100 X).

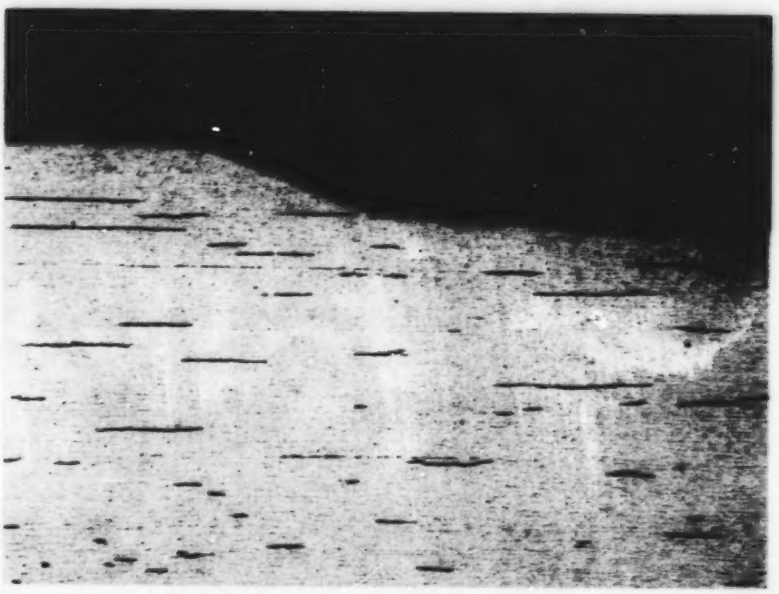
FIGURE 4(b) - Transverse ridge due to cast iron contact in F15-2-1 (100 X).

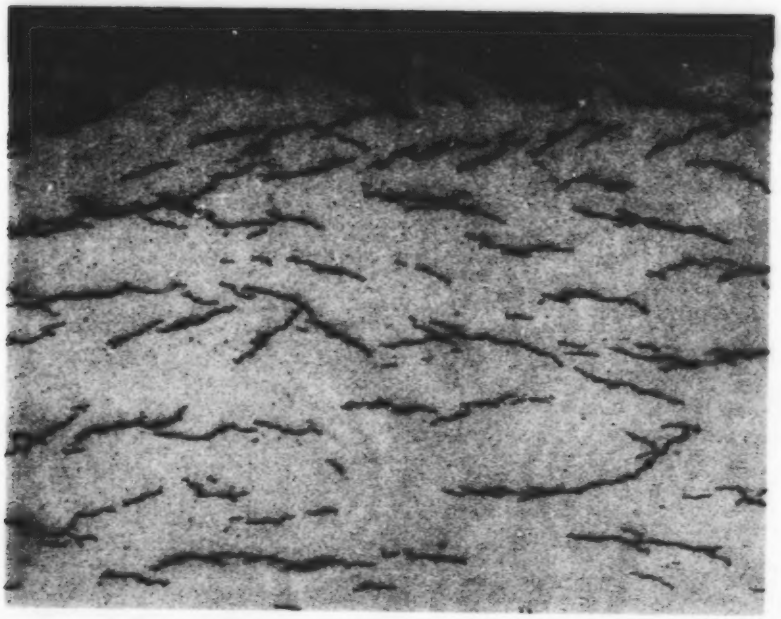
In many of the figures already presented, the hydrides are visible because the micrographs were taken from etched samples. Clearly in Figure 3(a) there is a very high density of hydride immediately beneath the fretted area. Figure 5 shows another area of the first fret mark in E08. There are some large packets of hydrides intersecting the surface at about a 45° angle in this section (axial normal). The hydride distributions through the wall thickness of all tubes were studied. As noted in the examination of the first tubes removed from Unit 8/2/, the distribution of hydride depended upon the fretting wear. In sections with relatively deep marks, there was more hydride near the surface where the fretting took place than towards the outside surface of the tube. In other sections where the fretting was less severe, there was less hydride and it was more uniformly distributed through the thickness. In most tube sections, the hydrides have orientations which vary from circumferential to close to radial in parts of the pressure tube wall (Figure 6(a)). This distribution of orientations is significantly different from the predominantly circumferential orientation observed in pressure tube sections hydrided in the laboratory without stress. In one tube from channel J12 there were distinctly radial hydrides towards the outer surface of the pressure tube (Figure 6b).

FIGURE 5 - Hydride distribution at surface of pressure tube in the first fret mark in channel E8 (100 X).

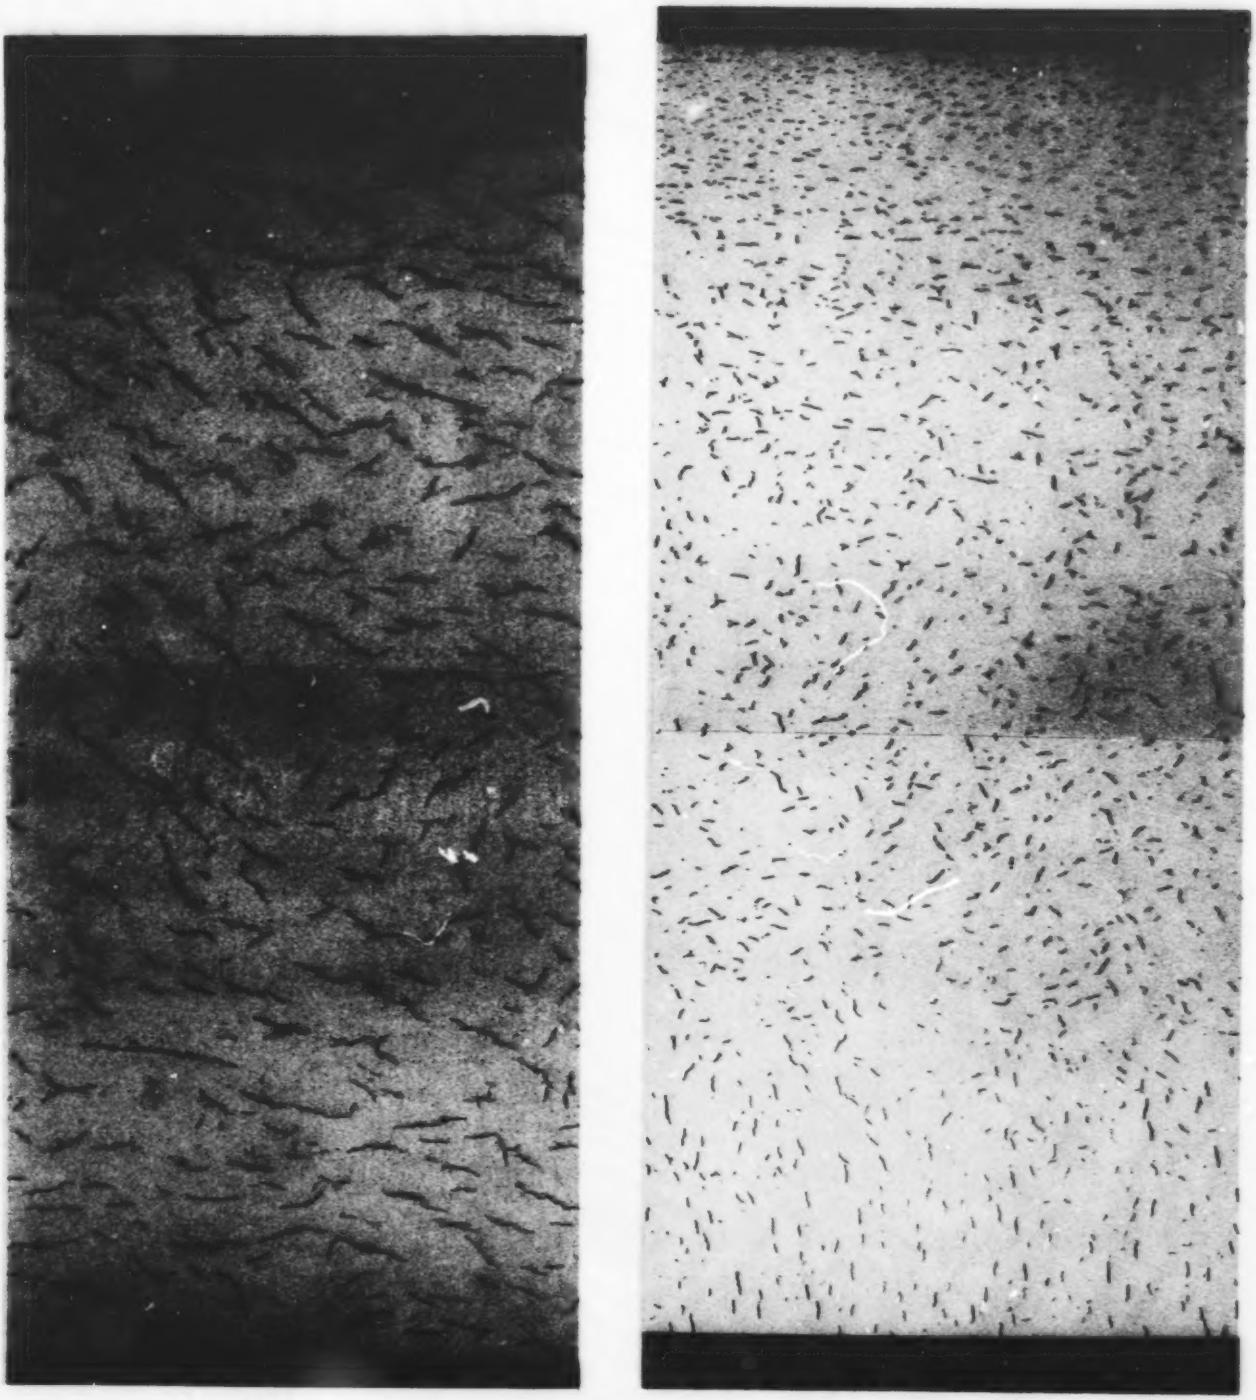
The presence of the zone of completely radial hydride under the fret mark in the J12 tube can be rationalized using the OHRD results which indicated a threshold stress of 180 MPa. Parts of J12 tube apparently retained significant residual stresses from manufacture. These were made apparent upon axial slitting of rings of material.

When a 15 cm length of tube containing the fret mark was slit axially, it was observed to open about 8 mm although no precise measurement was made. Two other rings each 5 cm long from different positions along the length of the tube approximately 20 cm and 1.15 m from the site cut at the inlet end were also slit and measured more precisely. The ring close to the inlet end opened 5.66 mm whereas the other ring closed about 0.1 mm. If a linear residual stress distribution through the wall is assumed with a compressive stress on the inside and a tensile stress on the outside, then the ring close to the inlet had a maximum tensile residual stress of 81 MPa. If the threshold stress for formation of radial hydride is exactly 180 MPa, then on a 4 mm wall thickness with an applied stress of 130 MPa and a residual stress distribution as measured, we would expect that 0.24 of the wall thickness would contain radial hydride. In fact, the observed fraction of the wall under the fret mark with radial hydride was estimated to be 0.21. Variation in both residual stress along the tube and threshold for formation of radial hydride could easily explain this discrepancy.

FIGURE 6 - Through-wall hydride orientation distributions under fret marks in tubes from Channels E8(a) and J12(b), (50X)

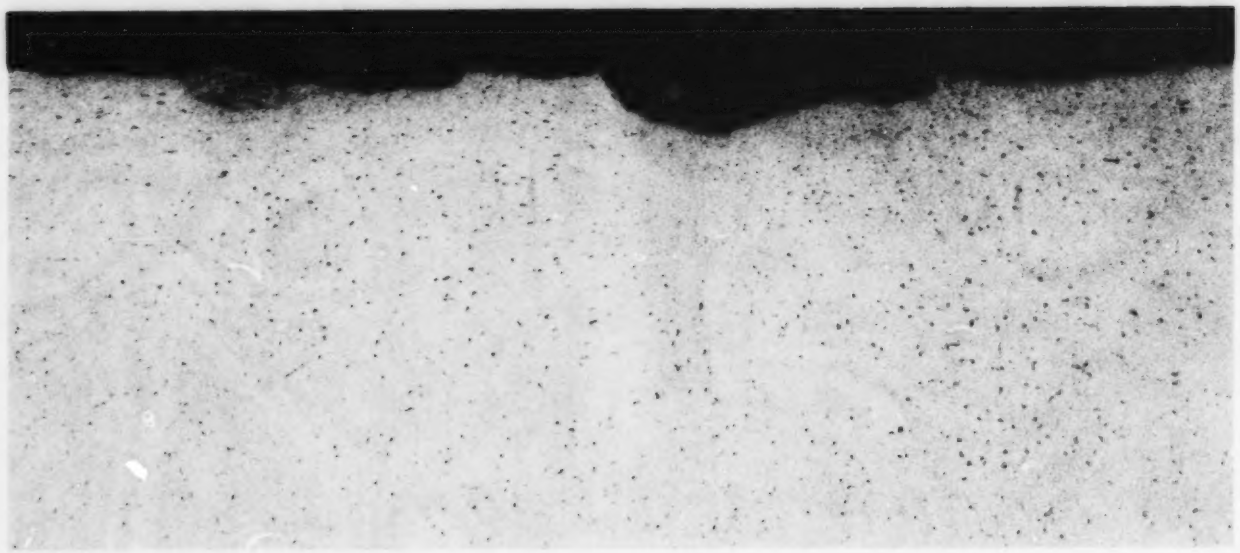
Figure 7 shows the cross section of the mark designated E8-3-1 at its deepest point. There is a particle embedded in the pit which was identified as ferrous material using the X-ray analysis capability of the SEM. Fine hydrides characteristic of as-received pressure tube are present in this cross section and there is some indication that the hydrides are finer close to the pit than they are at some distance away. There is no evidence for hydride orientation due to the stress field of the pit.

FIGURE 7 - Cross-section of secondary mark in section E8-3-1 (50 X). Imbedded particle was ferrous.

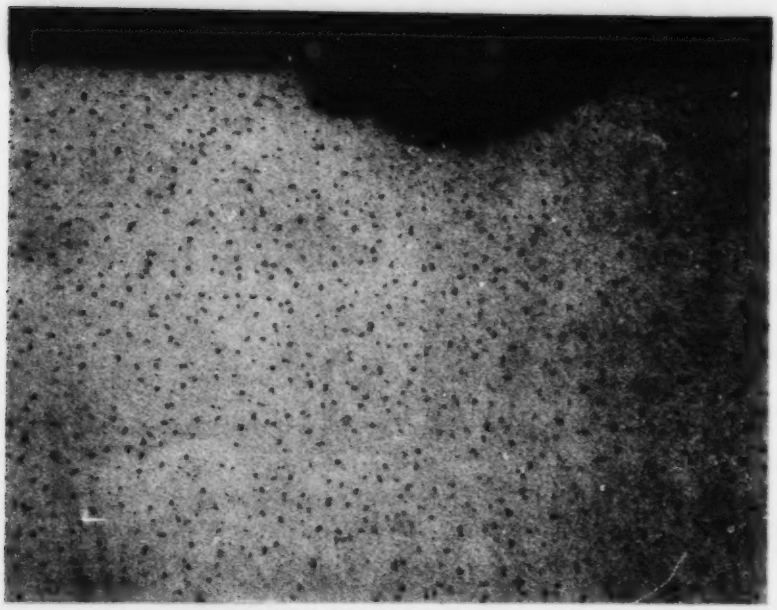
A cross section at the deepest part of the pit seen visually in channel J12 is shown in Figure 10. Again the hydrides are fine, characteristic of as-received material. There are a few finer hydrides close to the pit. The pit itself has a sharp corner at about one-half the maximum depth.

FIGURE 10 - Cross-section of secondary mark J12-5-1 at deepest point (50 X)

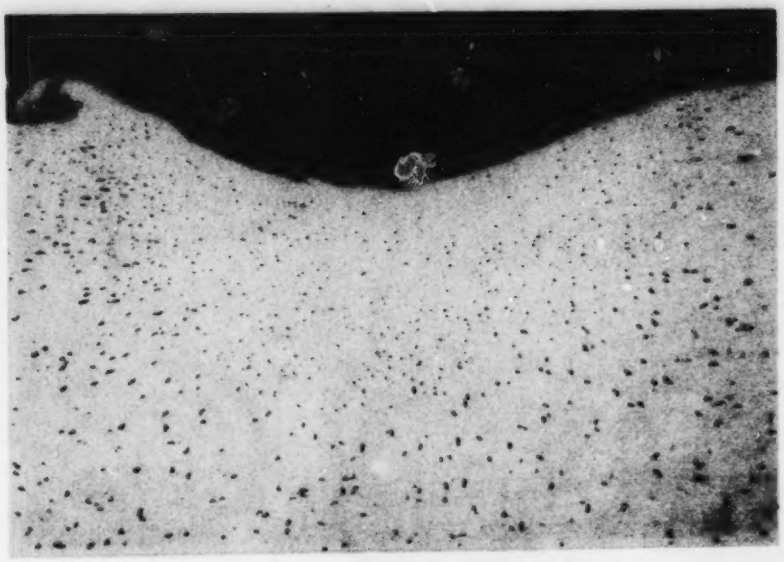
Three secondary marks were seen visually in channel K18. The cross sections through these marks (Figure 11(a-c)) exhibit characteristics which are somewhat different from those seen in marks in the other channels. Mechanical damage in these marks is more pronounced as indicated by the presence of significant upheavel of material which now is lapped over the edges of the pits. There is clear evidence of mechanical flow of material in Figure 11(a). Surrounding the mark designated K18-15 there is a large zone in which the hydrides are very fine.

FIGURE 11 - (a) Montage (transverse
mark in K18-1-6. Note

(transverse normal) through secondary
-1-6. Note material flow (100 X)

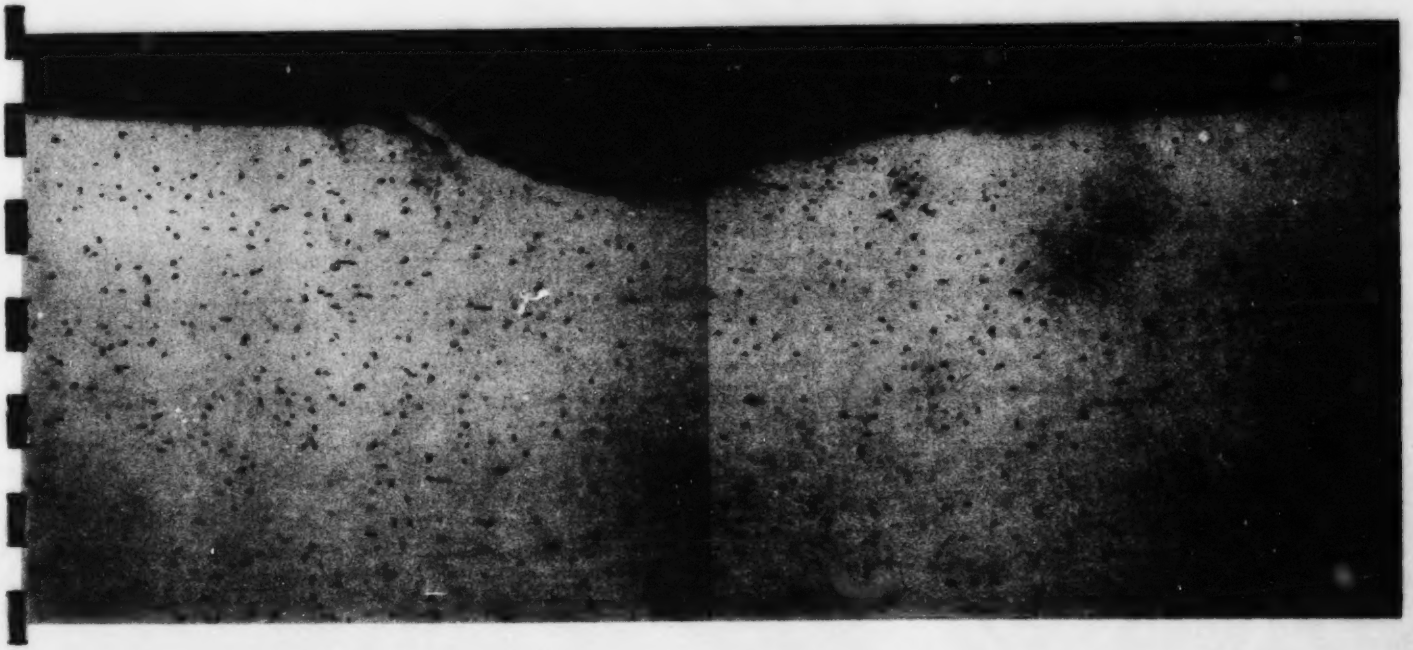
A microhardness trace through the zone of fine hydride beneath the secondary mark designated K18-15 did not indicate any alteration in microhardness associated with the hydride microstructure variation.

FIGURE 11 - (b) - Cross-section through K18-15 at deepest point. Note fine hydride zone (50 X).

(c) - Cross-section through K18-16 (50 X).

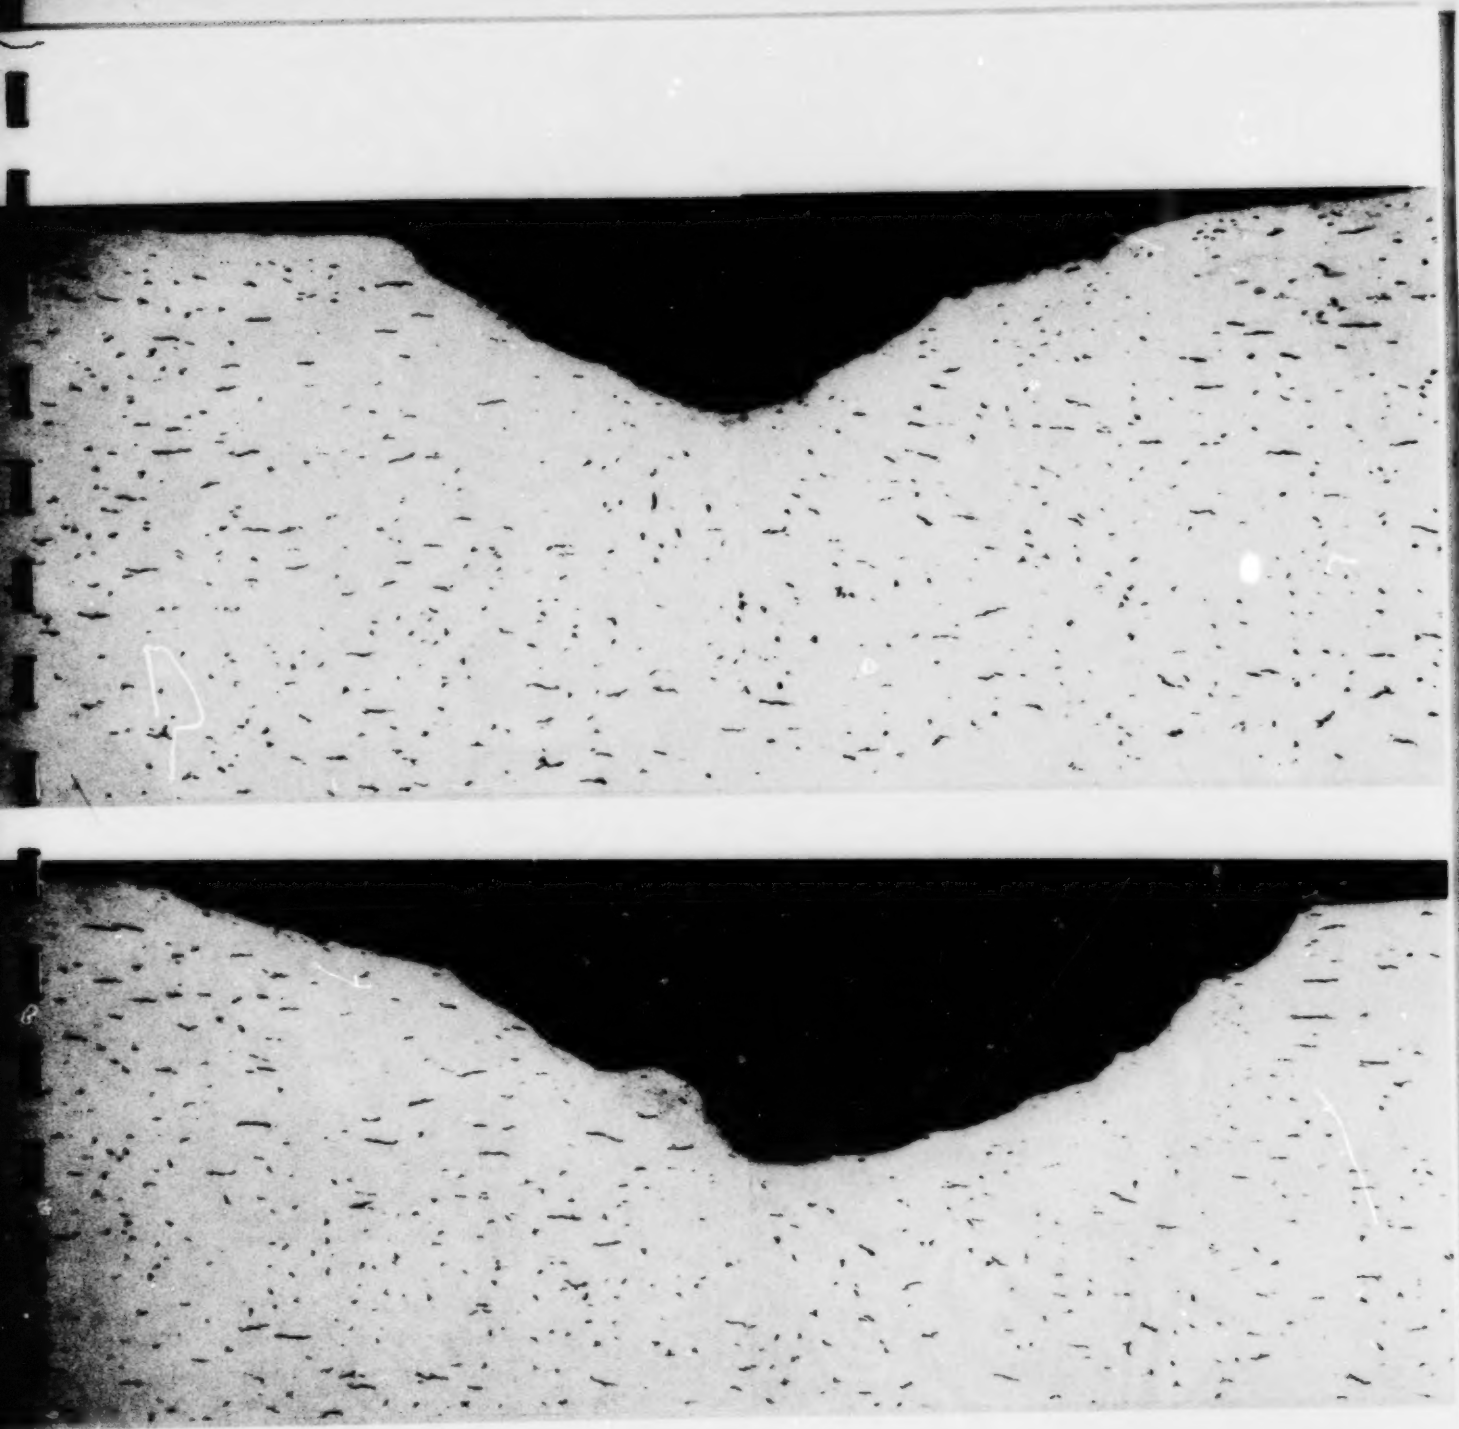
The deepest mark seen in any of the channels examined at OHRD was that in channel L14 which is shown in cross section in Figure 12. Hydrides in the cross section shown in Figure 12(a) tend to exhibit orientation due to the presence of the defect. However at the deepest point (Figure 12(b)), this hydride orientation is not evident. Hydride sizes are consistent with a hydrogen level slightly above the as-received level. The cross sections of three other secondary marks in L14 are also included in Figure 12.

FIGURE 12(a) - Cross-section through secondary mark in L14-3-1 (50 X).

(b) - Same mark at deepest point (50 X).

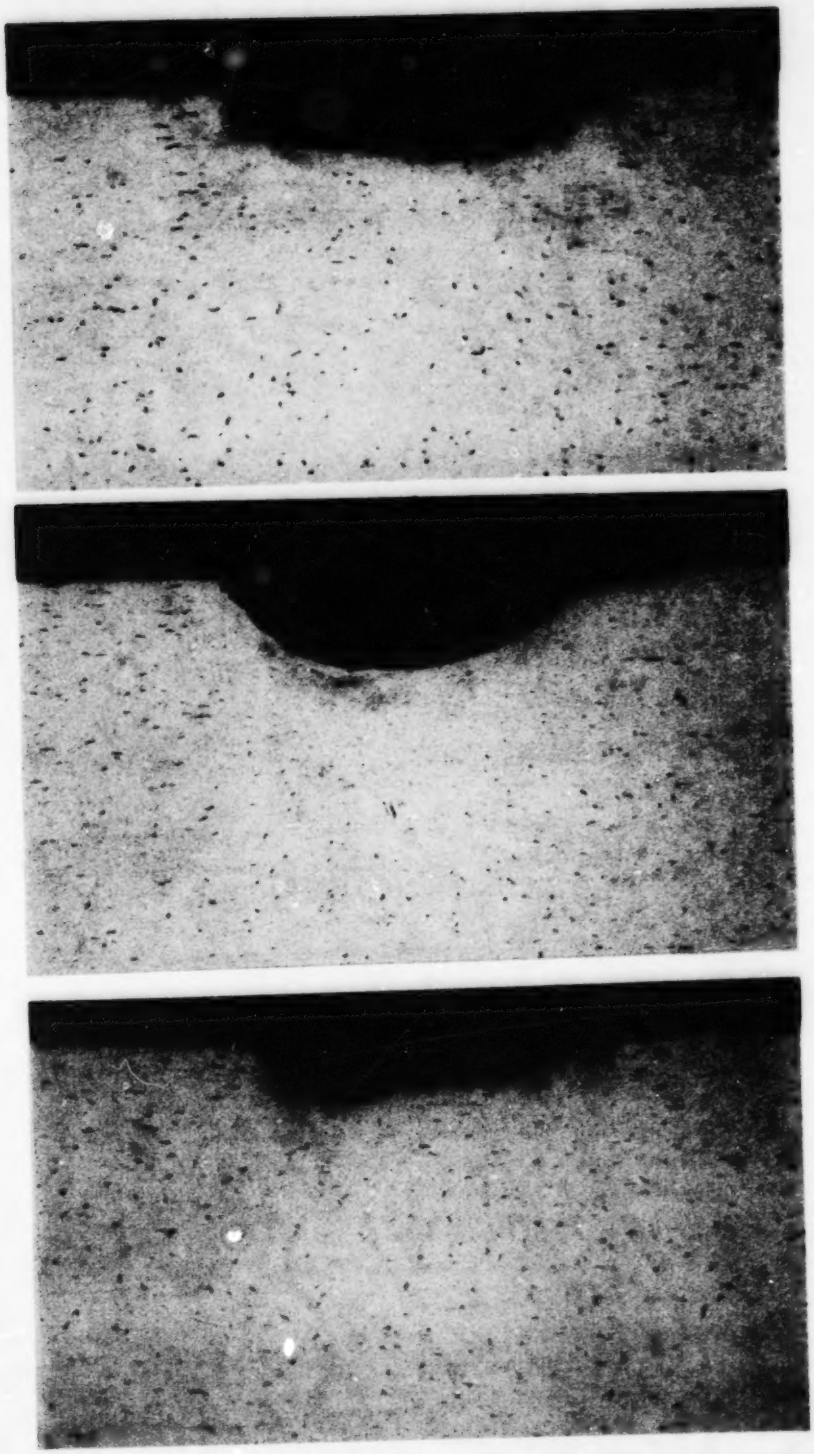
FIGURE 12(c) - Section through L14-3-2 at deepest point (50 X).
(d) - Section through L14-3-3 at deepest point (50 X).
(e) - Section through L14-3-4 at deepest point (50 X).
